Docket No. 217 – Development and Management Plan Inspection

Northeast Utilities Service Company Certificate of Environmental Compatibility and Public Need for the construction of a 345-kV electric transmission line and reconstruction of an existing 115-kV electric transmission line between Connecticut Light and Power Company's Plumtree Substation in Bethel, through the towns of Redding, Weston, and Wilton, and to the Norwalk Substation in Norwalk, Connecticut.

Date: August 16, 2005

Location: 345kV XLPE Component

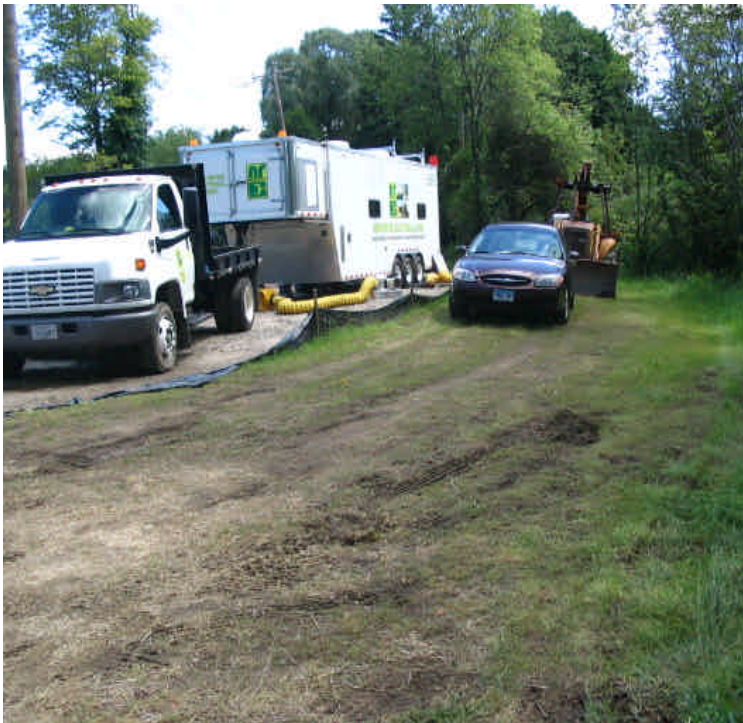
345kV XLPE: Photo on the left shows vault #2 where splicing and cable work is occurring. Temporarily restored areas were being used for vehicle parking. Reseed when access is complete. Photo on the right shows some minor tracking to the newly paved Walnut Hill Rd. Sweep as necessary. 8/16/06

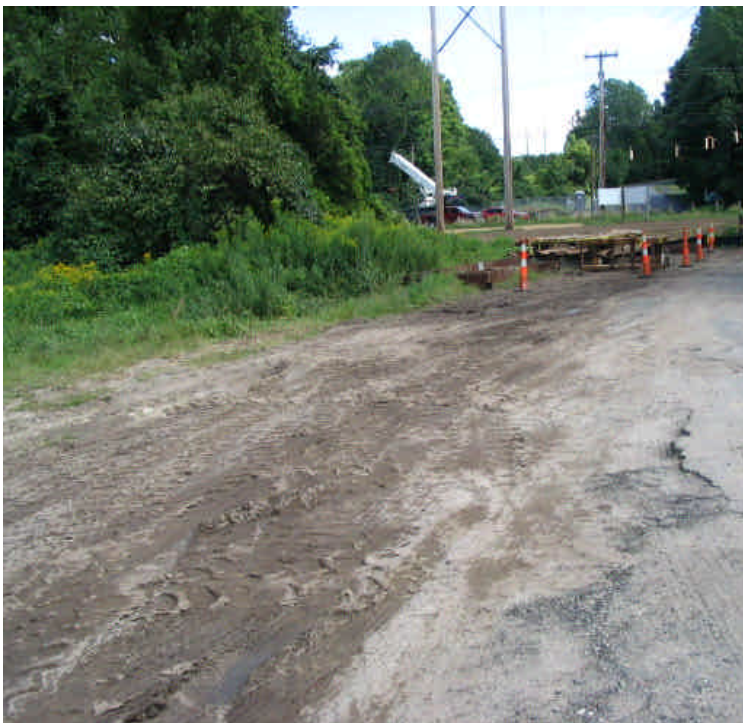
Photo on the left shows some disturbed areas remaining along the ball park access road. This spot should also be restored to previous conditions when feasible. Photo on the right shows the good efforts to restore the lawn area adjacent to the stream. Silt fence is also in place. 8/16/06

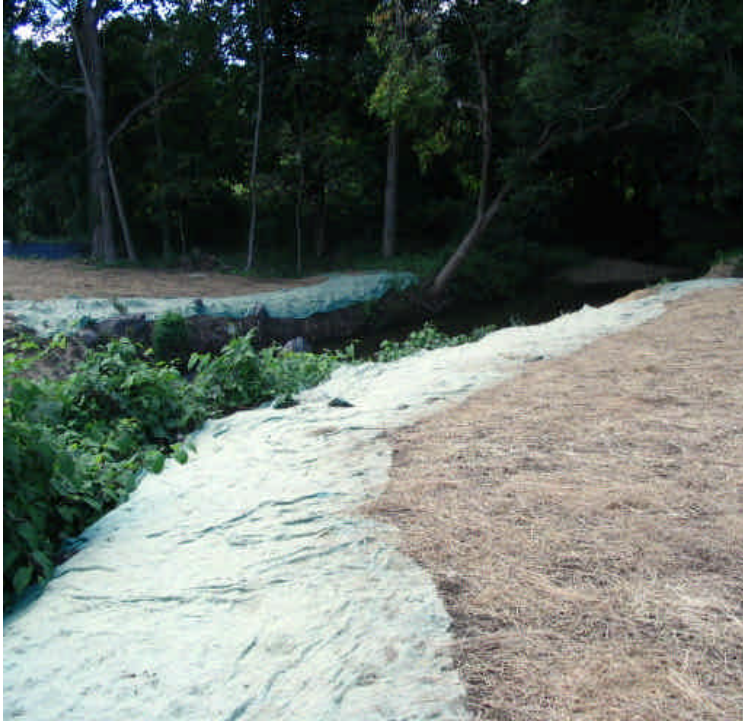
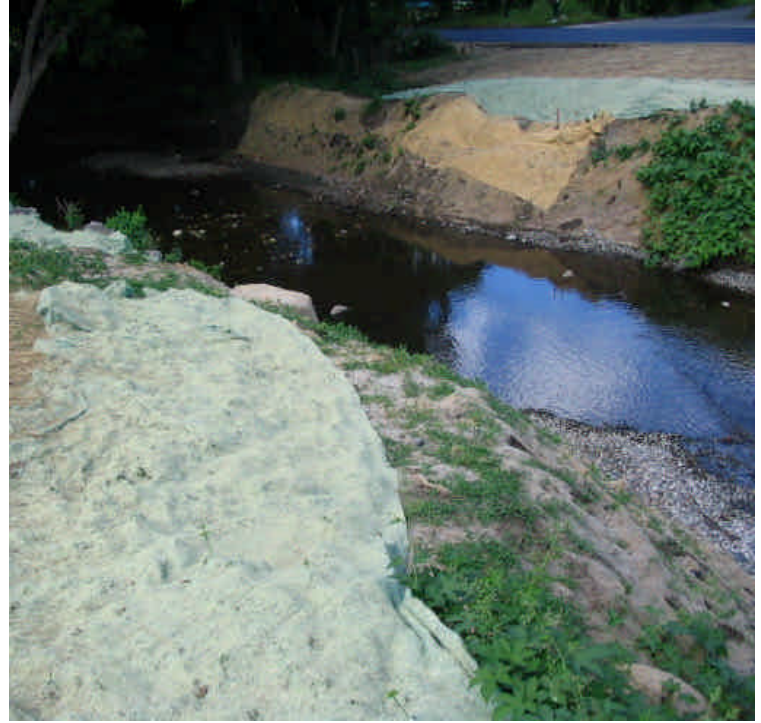
Both photos show the restoration efforts along the stream banks. The tops of slope were seeded and mulched and erosion controls blankets were repaired along the bank. Vegetative cover was beginning to establish here. 8/16/06

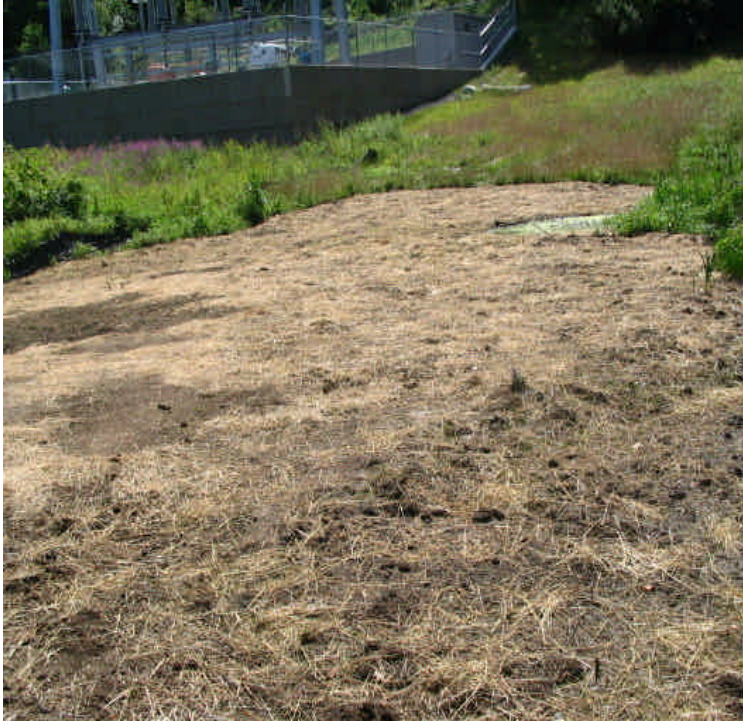
Photo on the left shows the wetland at the base of slope at Hoyts Hill. Mats were removed and the area was restored. Photo on the right shows where grinding and repaving is occurring along Rt 58. Watch asphalt tracking to areas outside of the work. 8/16/06
